HOT SALT STRESS CORROSION STUDIES

R. L. Fowler and A. J. Luzietti
Pratt & Whitney Aircraft Group
United Technologies
West Palm Beach, Florida 33402

1 JUNE 1978

Final Technical Report for Period 1 April 1976 - 1 June 1978

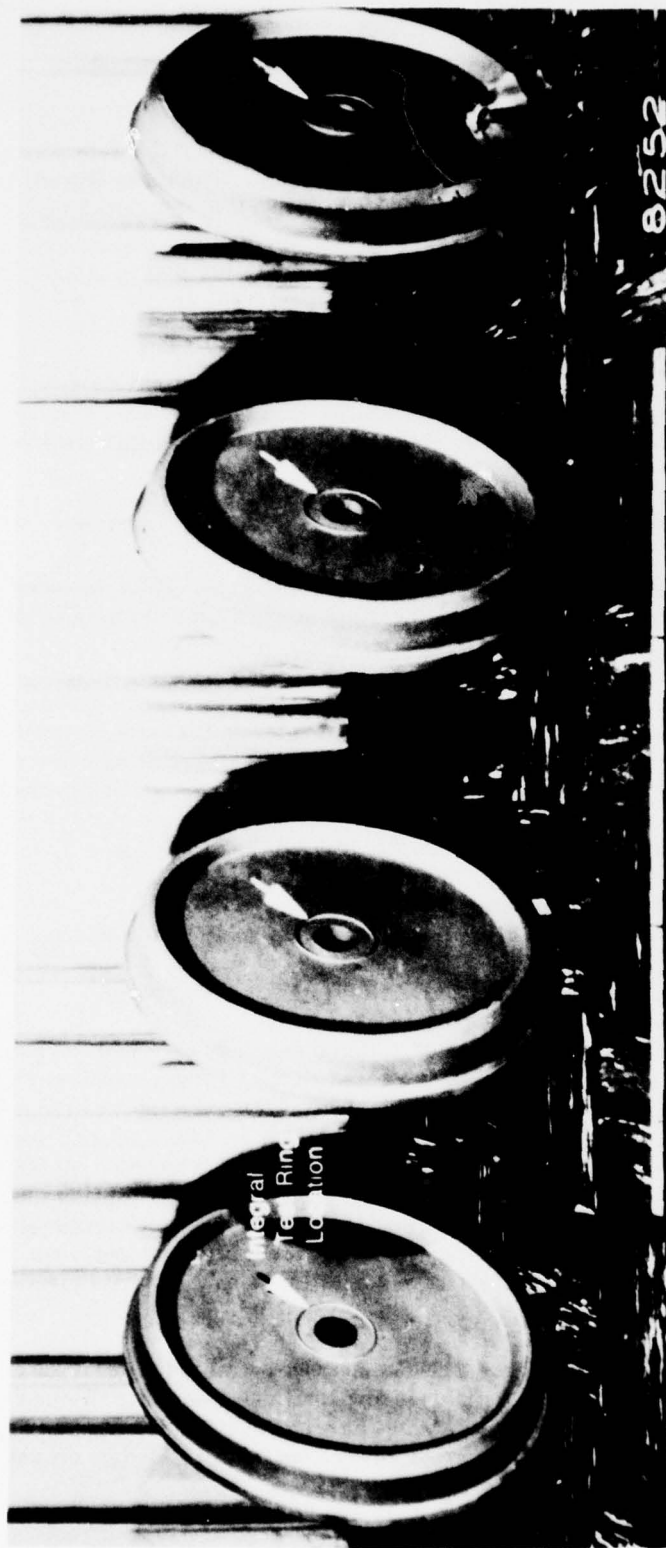
FD-1408

Figure 1. Isothermally Beta Forged Ti-6Al-2Sn-4Zr-2Mo Disk Type Forgings for HSSC Test Specimens

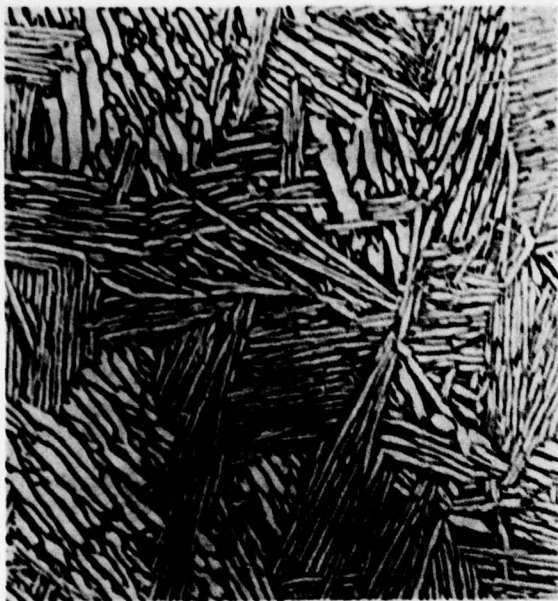
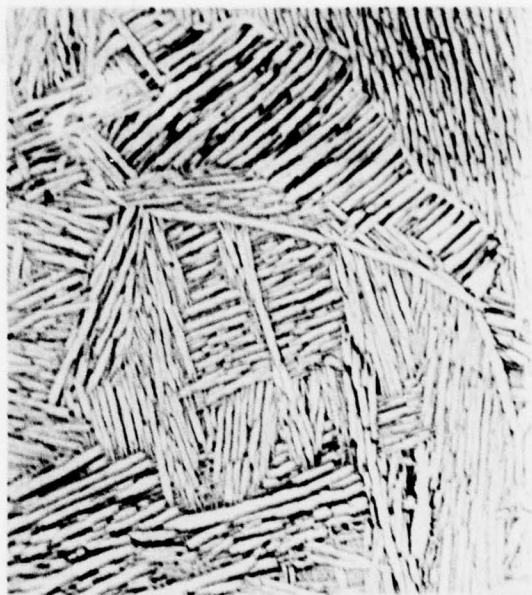
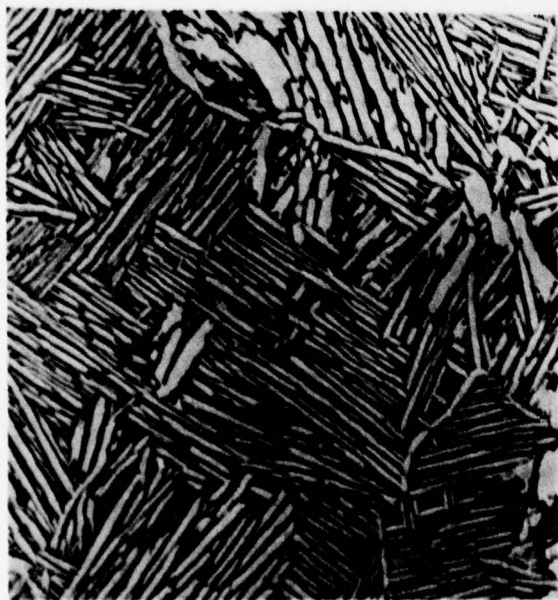
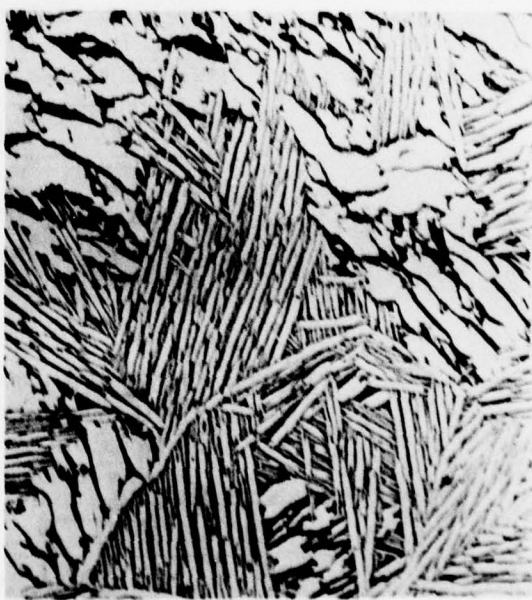
FD 143081

Figure 2. Typical Microstructures of Isothermally Beta Forged Ti-6Al-2Sn-4Zr-2Mo

Metallographic examination of selected specimens from the four beta processed disks revealed a microstructure of acicular alpha platelets arrayed in colonies with some outlining of prior beta grain boundaries by alpha (Figure 2). The microstructures are typical of those of beta processed Ti-6-2-4-2 alloy in the solution treated and aged condition.

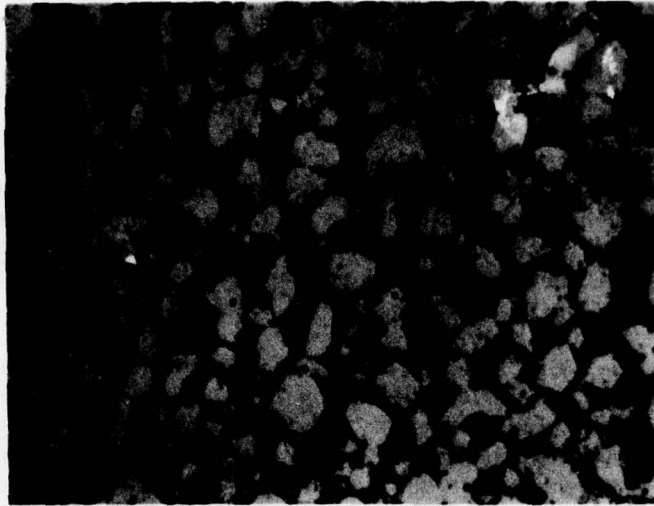
FD 143082

Figure 3. Typical Microstructure of Alpha-Beta Processed Ti-6-2-4-2 P/N 2F-744107, LZUN-2003

Metallographic examination of the alpha-beta processed forging revealed equiaxed alpha in a transformed beta matrix (Figure 3). The microstructure is typical of alpha-beta processed Ti-6-2-4-2 alloy in the solution treated and aged condition.

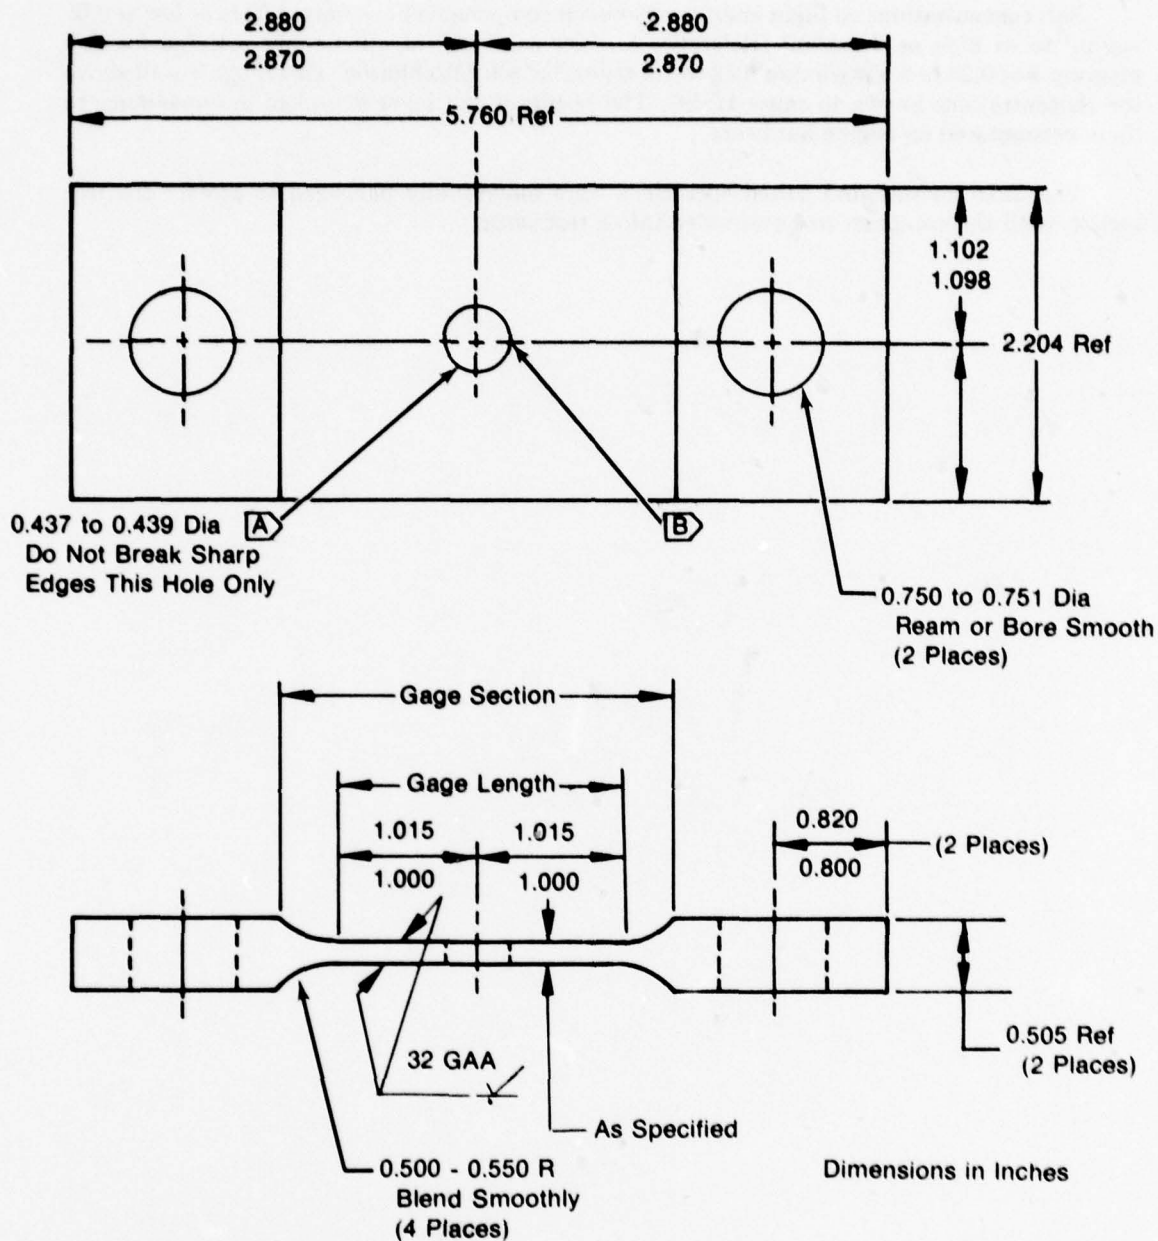
FD 143083

- Surface Finish Per Spec PWA 351
- Holes Must be on \perp Within 0.002 FIR and Perp With Plane of Gage Section Within 0.002 FIR
- Gage Length Thickness Must be 0.180 - 0.210 for Drill and Bore of Hole [A]
- Gage Section Must be Ground
- Drill Hole [A] 27/64 Dia Thru Bore 0.437 to 0.439 Dia One Pass 600 \pm 50 rpm
Feed 0.002 In/Rev Cutting Fluid PMC 9252 "Broach Oil" Boring Tool Quill No. 267912-T-47
Bit No. 254610-T-2-CH6F
- Any Unavoidable Withdraw Marks Must be at Location [B]

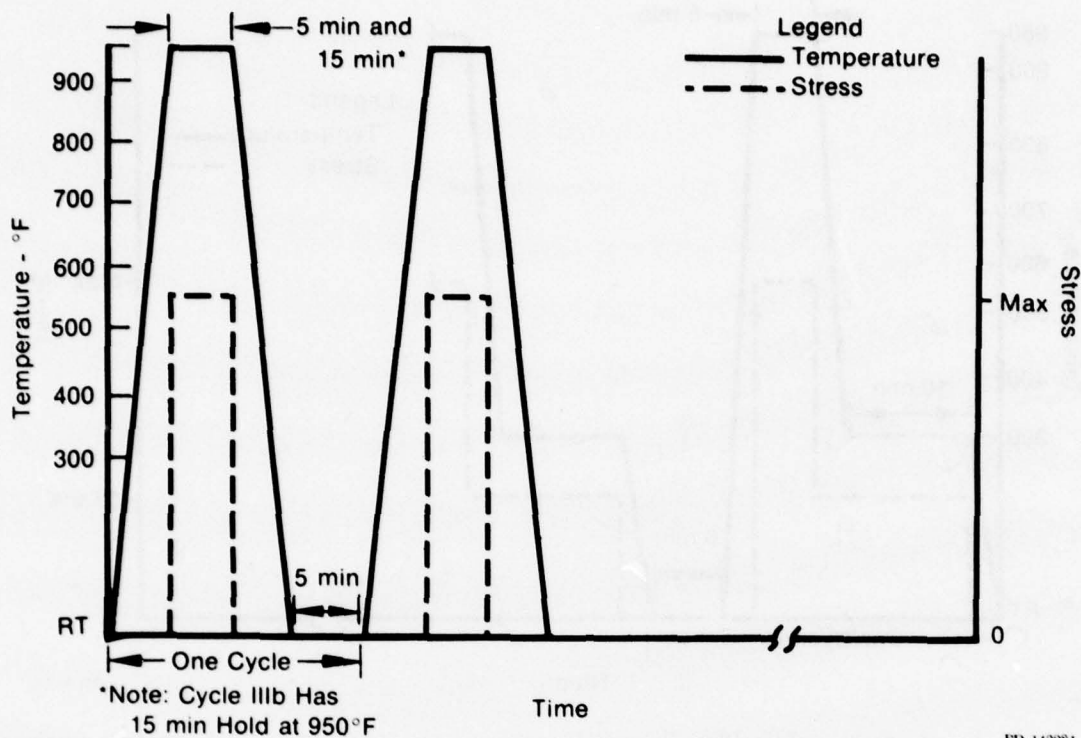
Figure 5. Basic Cycle, Cycle III (Resalt), and Cycle IIIb — Takeoff Plus Shutdown Dwell Stress-Temperature Cycle Simulation

Cycle IIIb, shown in Figure 5, was similar to the Basic Cycle, but with the takeoff duration increased from 5 min to 15 min to evaluate the effect of a prolonged takeoff condition.

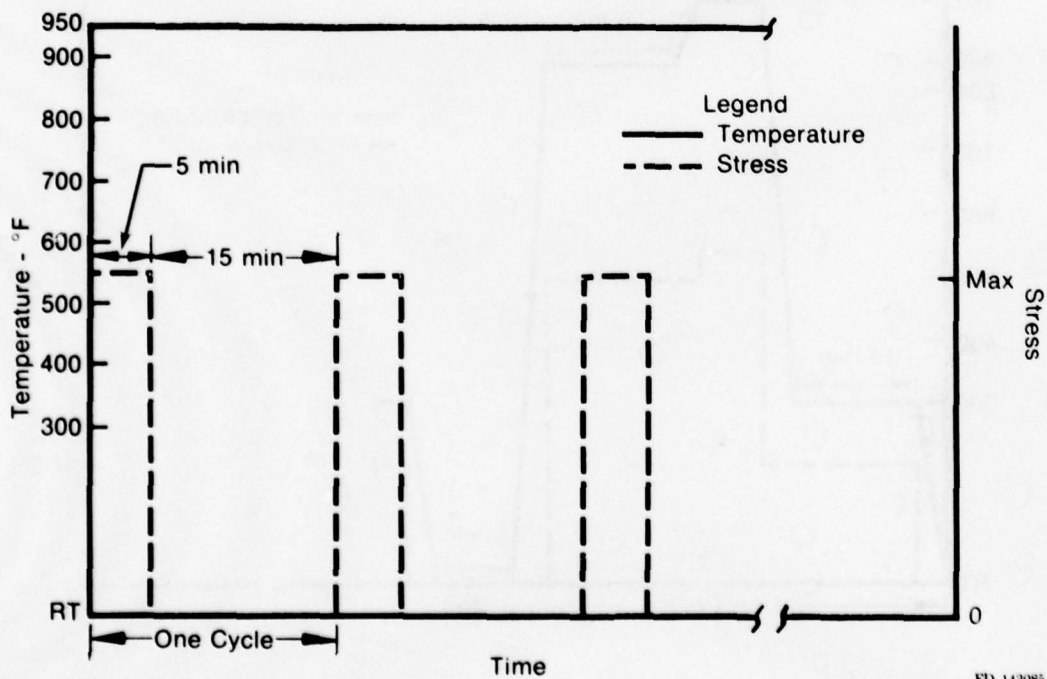
Figure 6. Cycle II — Takeoff Cyclic Stress-Constant Temperature Test

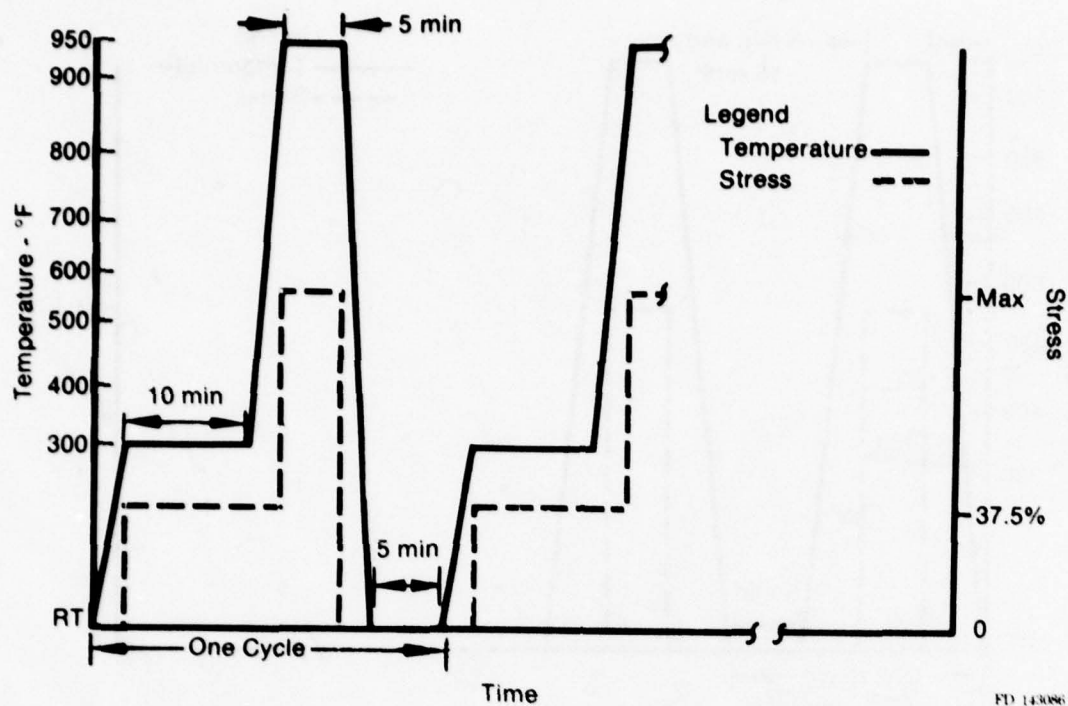
FD 143086

Figure 7. Cycle V — Idle Plus Takeoff Plus Shutdown Dwell Stress-Temperature Cycle Simulation

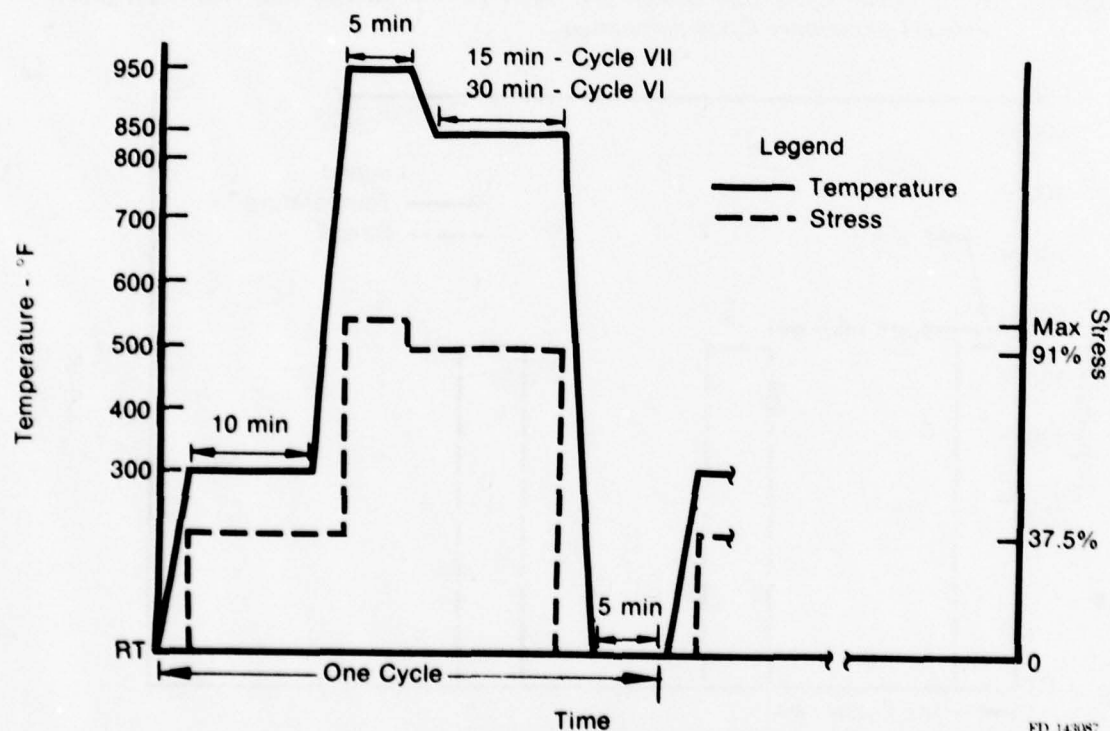
FD 143087

Figure 8. Cycles VI and VII — Idle Plus Takeoff Plus Cruise Plus Shutdown Dwell Stress-Temperature Cycle Simulation

Phase II testing was carried out on both beta and alpha-beta materials at various simulated takeoff temperatures to assess the effects of microstructure and temperature on cyclic HSSC behavior. From the results of Phase I testing Cycle VII (Figure 8) was selected as the test cycle for all Phase II testing.

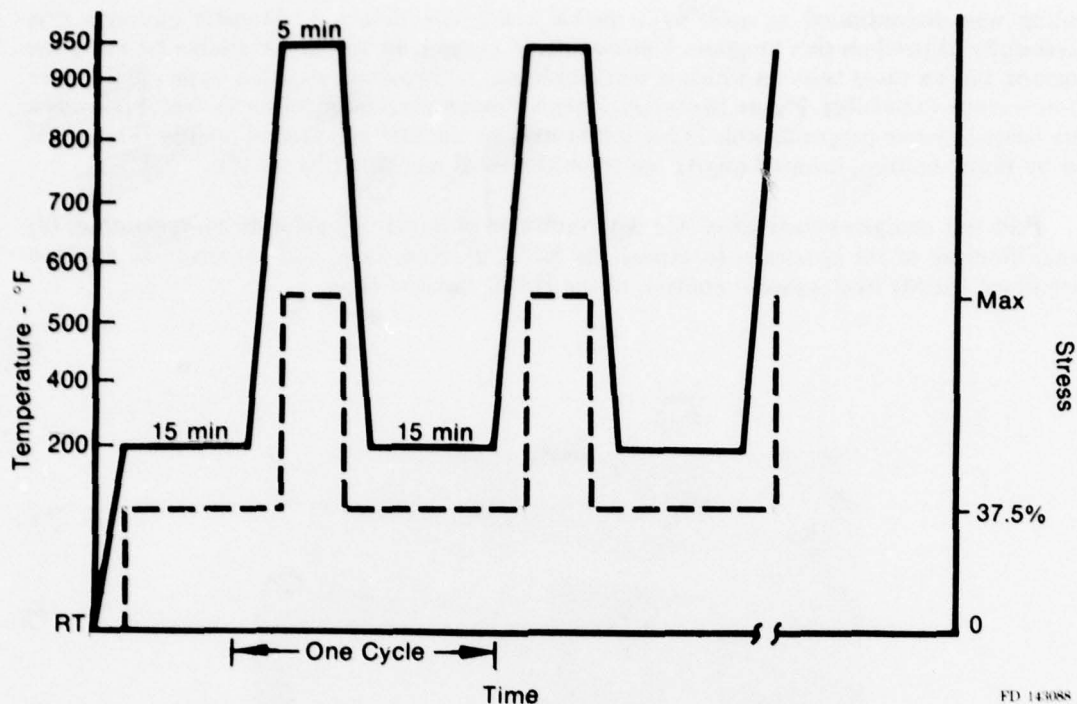
Figure 9. Cycle VIII — Takeoff Plus Hot Shutdown Dwell Stress-Temperature Cycle Simulation

Cycle VIII, shown in Figure 9, was similar to the Basic Cycle, the ambient temperature/no load shutdown dwell being replaced by a 15-min, 200°F, low stress shutdown dwell. The Cycle VIII shutdown stress was established as 37.5% of the takeoff stress. The 200°F shutdown dwell was incorporated to simulate a short stop between flights when the heat soak-back on shutoff maintains some intermediate temperature until the next takeoff.

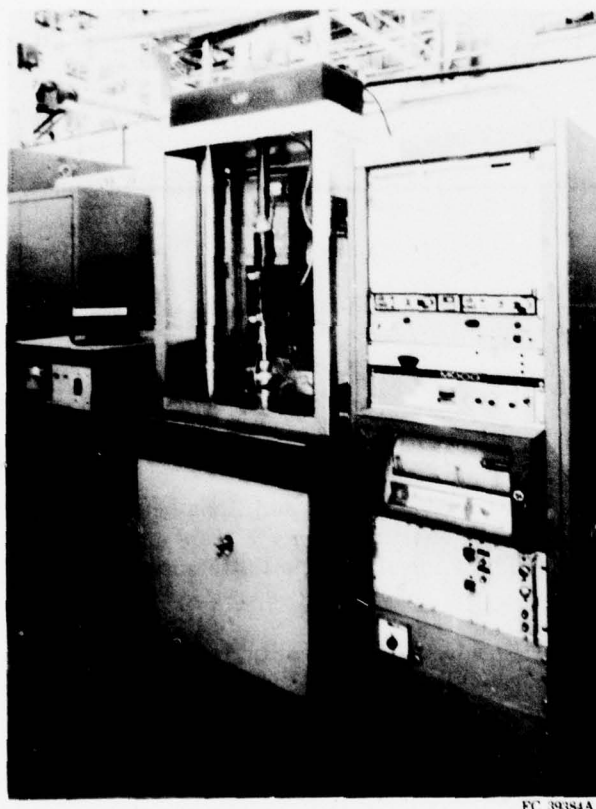
Figure 10. Thermal-Mechanical Low-Cycle Fatigue Rig No. LCF 3

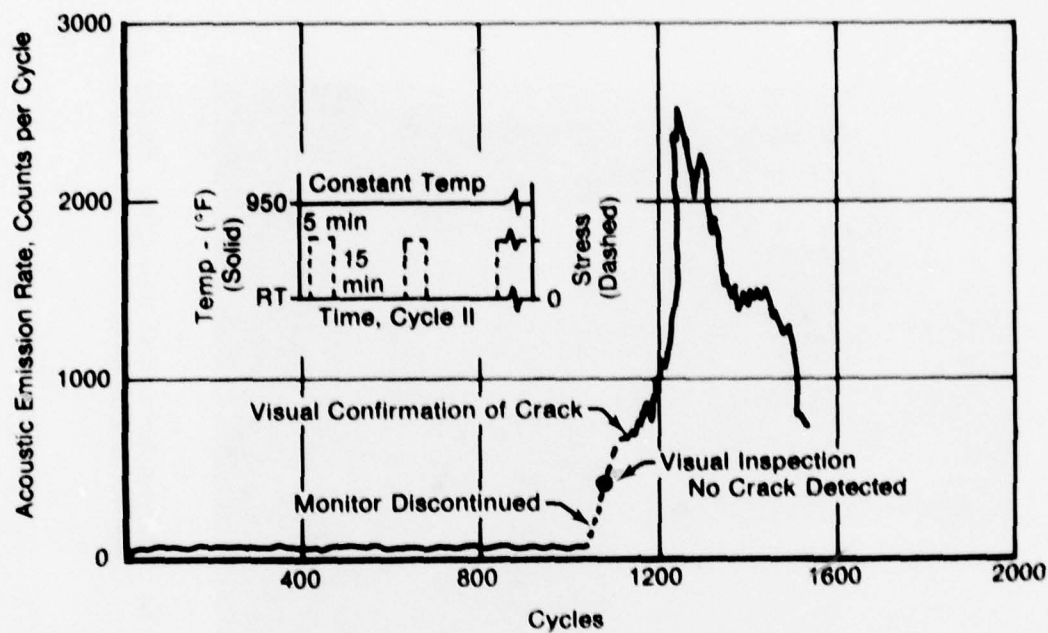
Figure 13. Acoustic Emission Rate Monitor HSSC Bolthole Specimen No. 5786, Ti-6-2-4-2, Cycle II, 25 ksi Maximum

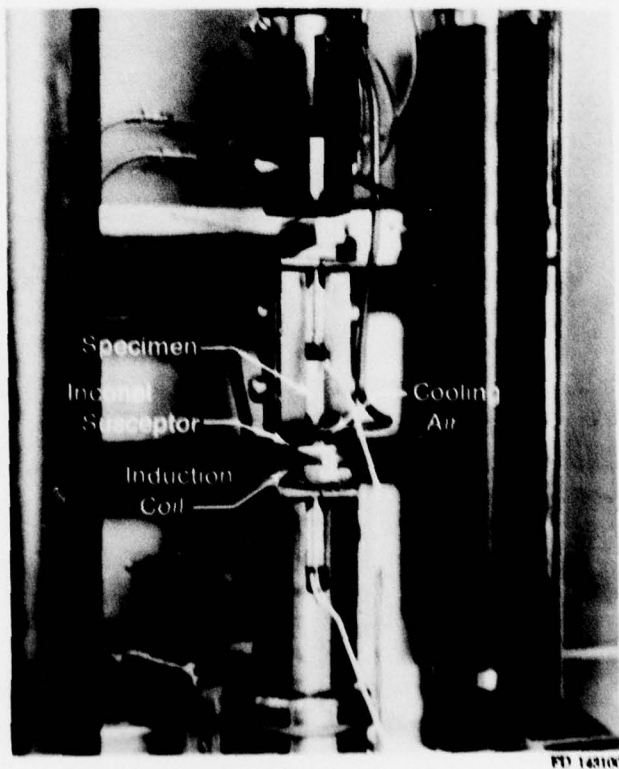
Figure 14. Typical Two-Specimen Test Setup Using Induction Heating

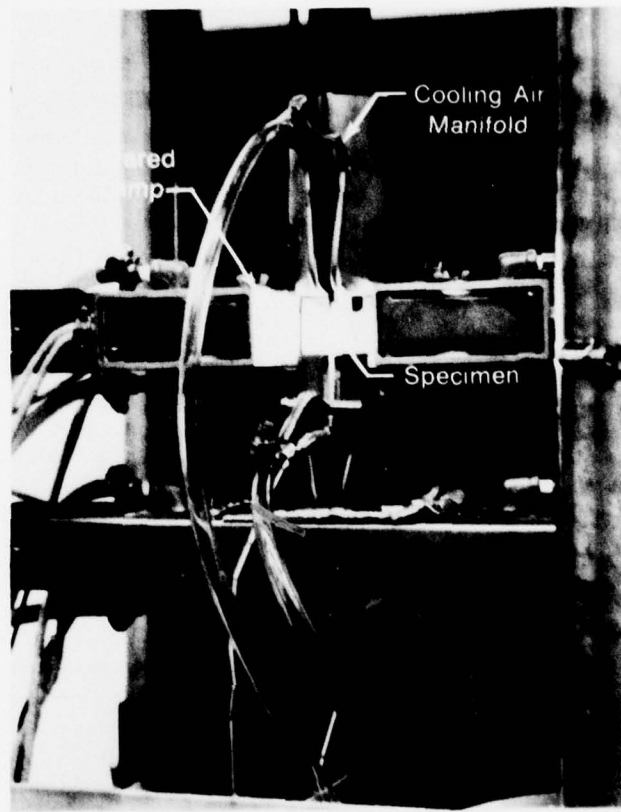
FD 137000

Figure 15. Typical Infrared Lamp-Heated Two-Specimen Test Setup Showing Side Reflector Removed from Upper Assembly

Testing was discontinued as soon as a visible crack was detected. Acoustic emission was successfully utilized on this program. Unfortunately, equipment was not available for all of the program, but on those tests on which it was employed, it frequently signaled impending failure before a crack was visible. Figure 13 shows the acoustic emission history of such a test. Specimens were heated by two programmable induction heaters on the first and second facility (Figure 14) and by radiation from infrared quartz lamps on the third machine (Figure 15).

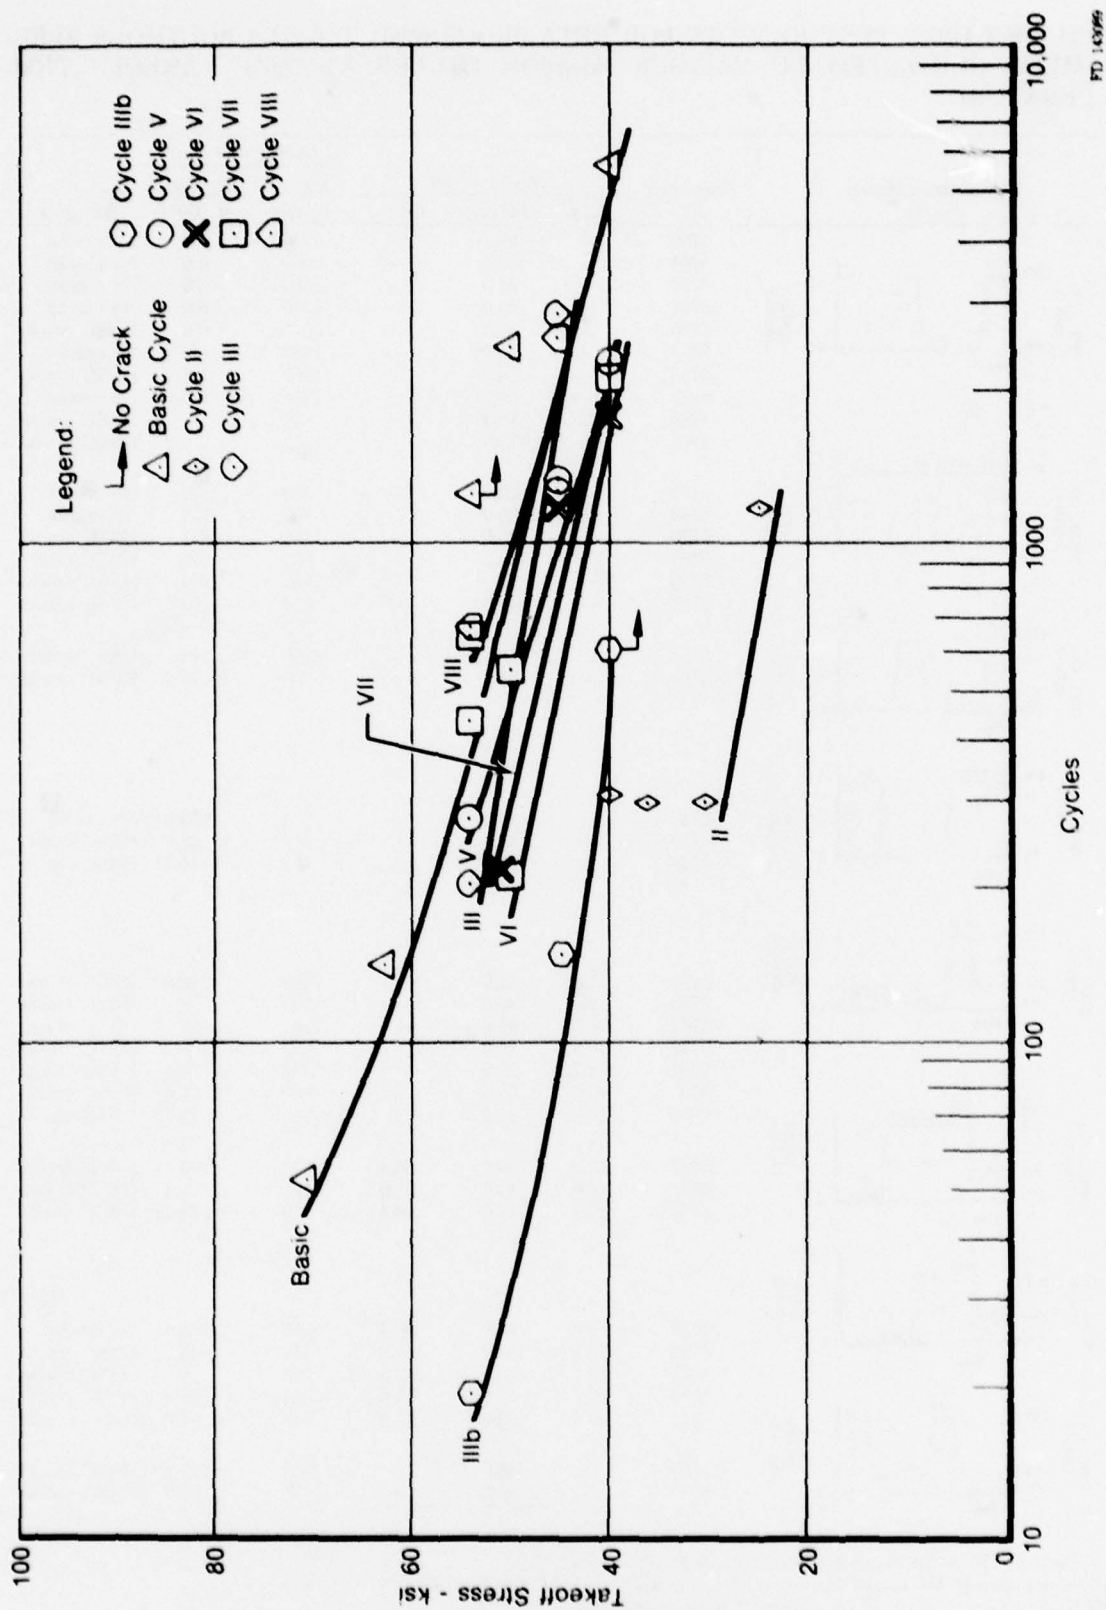
Figure 16. Phase I HSSC Crack Initiation Curves

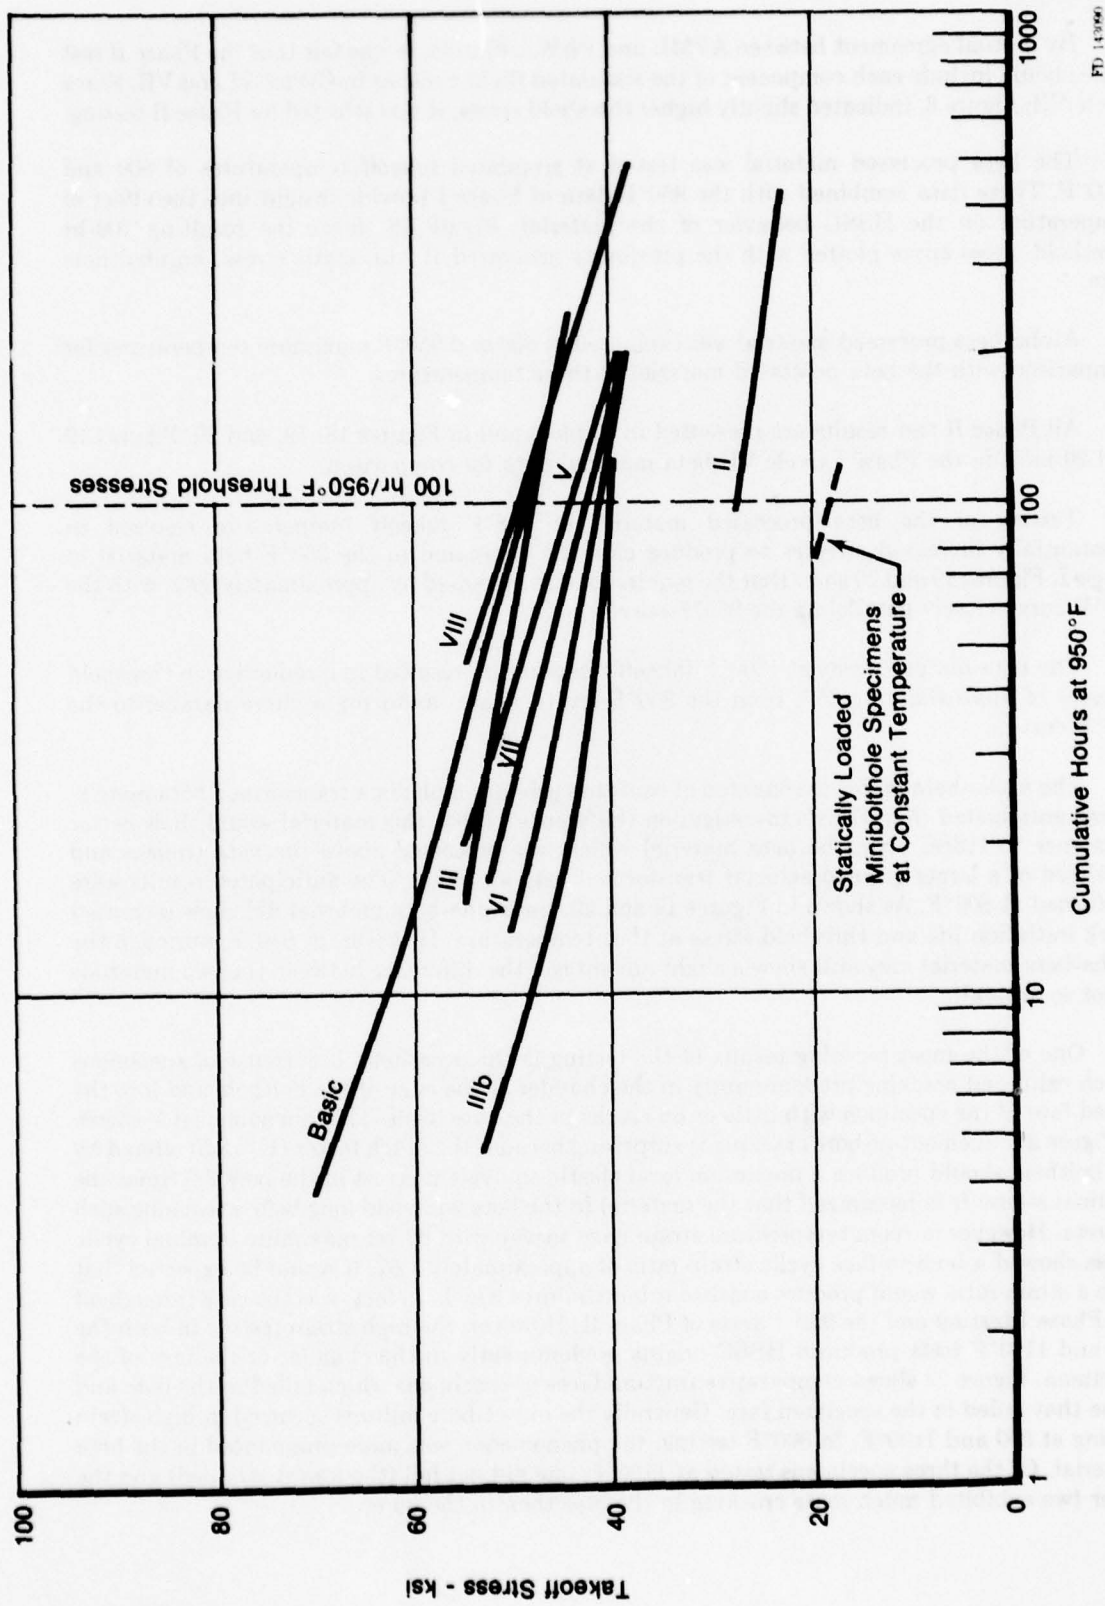
FD-1430-66

Figure 17. Phase I 950°F HSSC Threshold Stresses

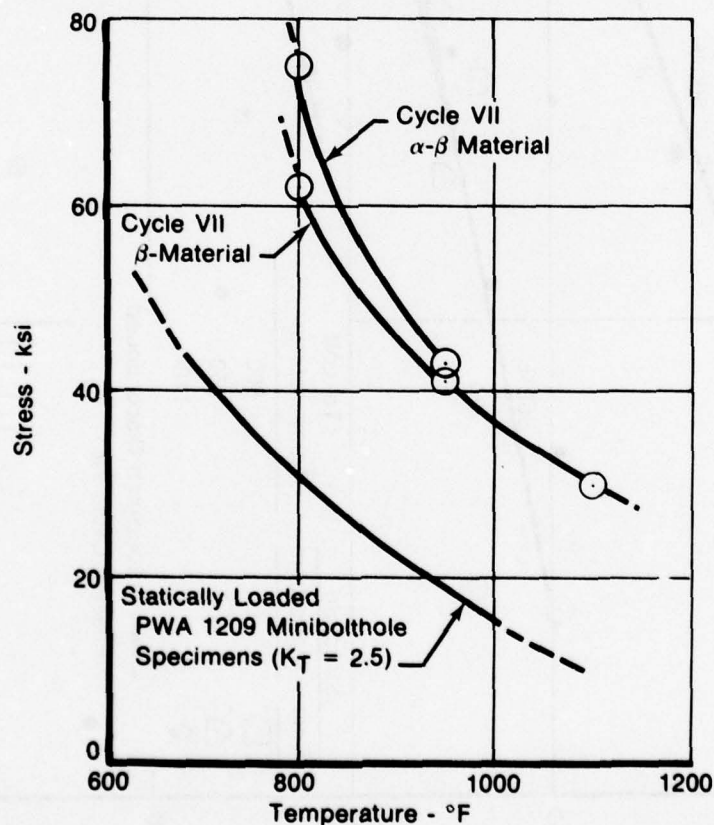
FD 143091

**Figure 18. Ti-6-2-4-2 Hot Salt Stress Corrosion 100-Hour
Threshold Stress Curves**

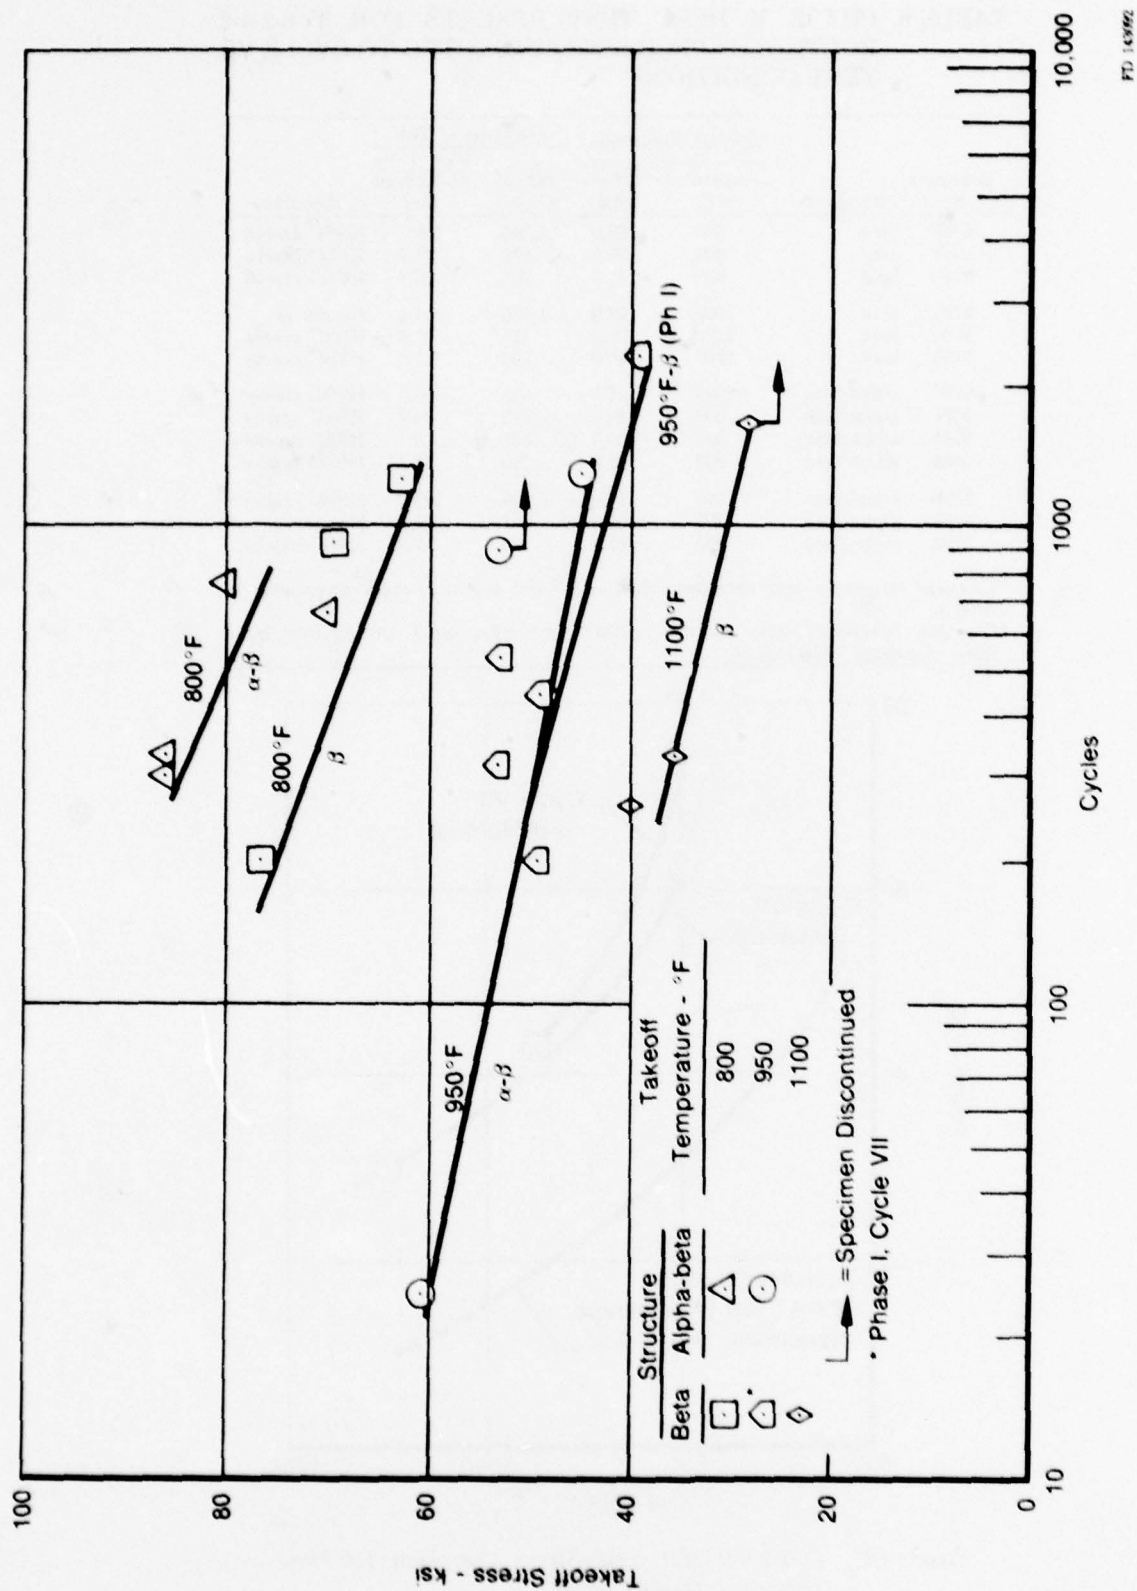
FD 145992

Figure 19. Phase II HSSC Crack Initiation Curves

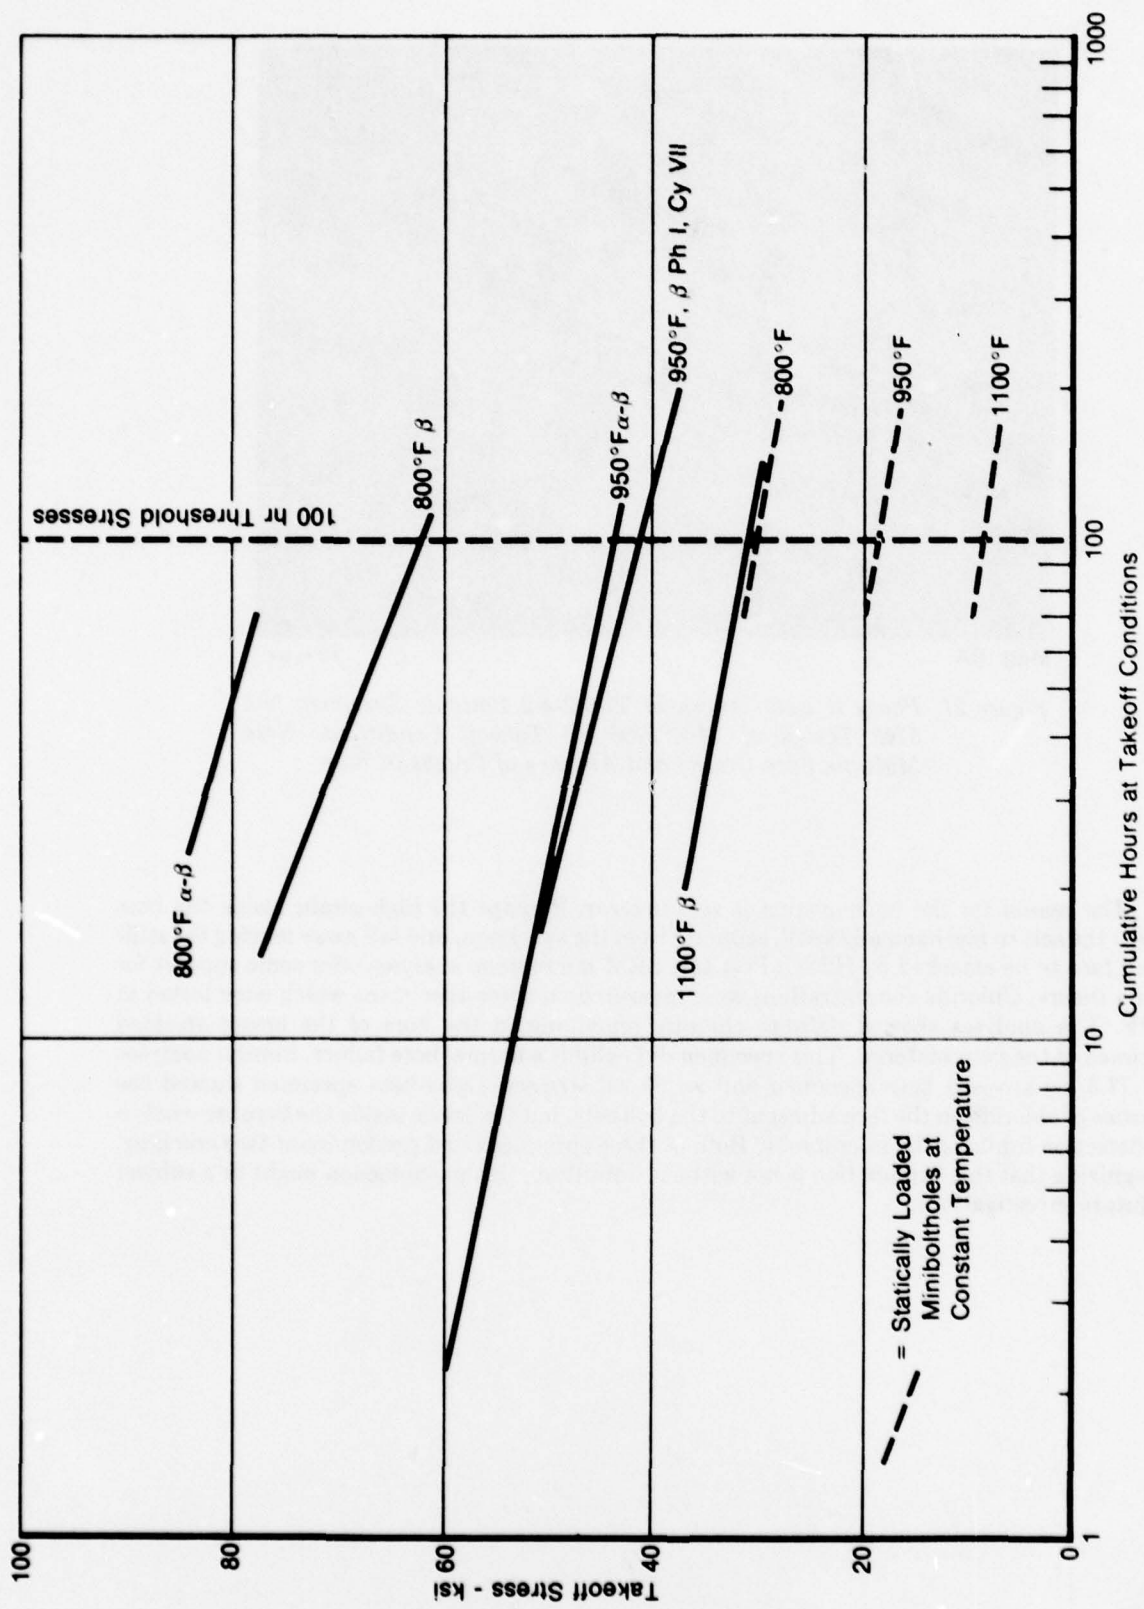
PTD 143960

Figure 20. Phase II Threshold Stress Curves

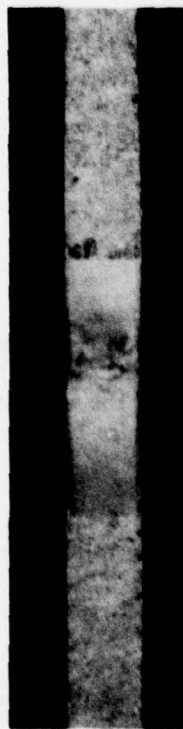
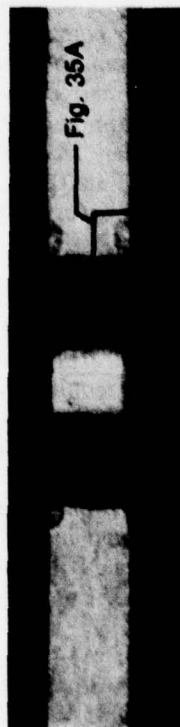
A. Beta Specimen No. 5738, Cycle VII, 950°F Takeoff Temperature, Crack Origins Inside Bore

C. Alpha-Beta Specimen No. 5776, Cycle VII, 950°F Takeoff Temperature, Crack Origins Inside Bore

B. Beta Specimen No. 5747, Cycle VII, 800°F Takeoff Temperature, Crack Origins at Face and Chamfer

Figure 22. Ti-6-2-4-2 HSSC Bolt-hole Specimen Crack Origins

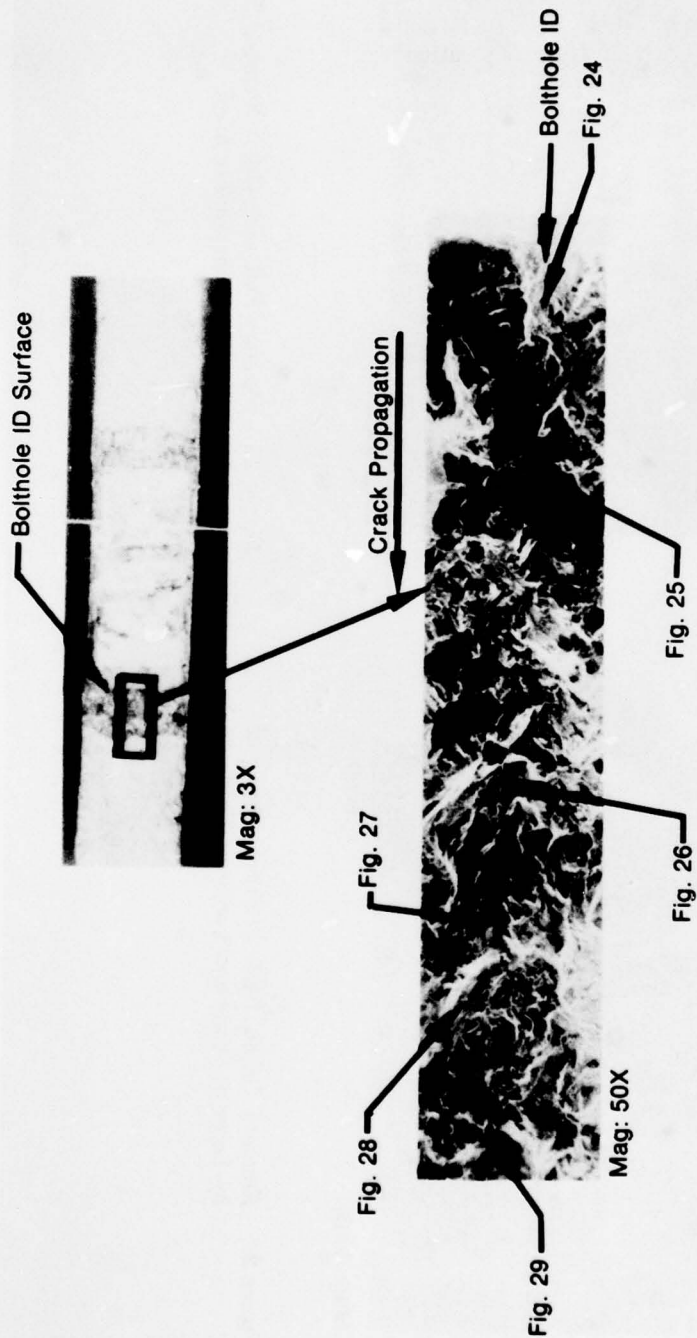
FD 111975

Figure 23. Photomicrograph of Typical Stress Corrosion Initiated Fracture Face of β -Processed Ti-6-2-4-2 Bolthole Specimen No. 5782 After Cycle II Testing at 40 ksi Maximum Stress for 635 Cycles

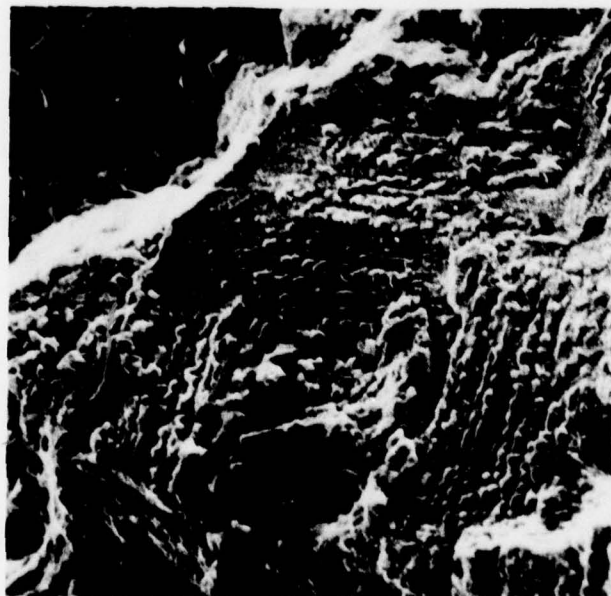
Figure 24. Fracture Origin With Features Obscured by Layer of Oxide and Corrosion Products

<i>Crack Penetration Depth (in.)*</i>	<i>Weight Chloride (%)</i>	<i>Fracture Surface Description</i>
0	1.03	Corrosion Products and Cleavage (Figure 24)
0.010	0.96	
0.020	0.21	Cleavage (Figure 25)
0.030	0.16	
0.040	0.12	Cleavage/Fatigue Transition (Figure 26)
0.050	0.10	
0.060	0.07	
0.070	0.06	Fatigue (Figure 27)
0.080	0.05

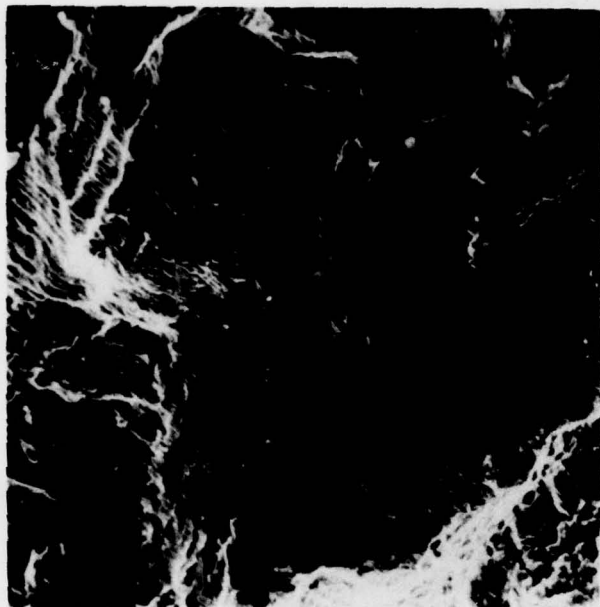
Figure 27. Typical Fatigue Following the Area of Transition from Cleavage to Fatigue

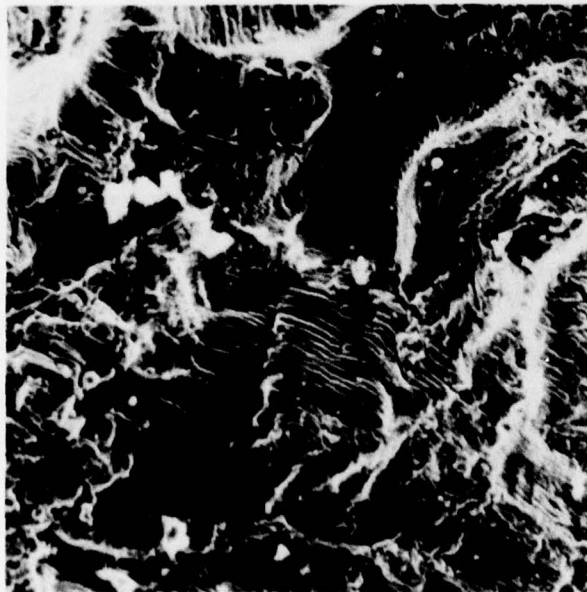
Figure 28. Typical Fatigue Near End of Crack Penetration

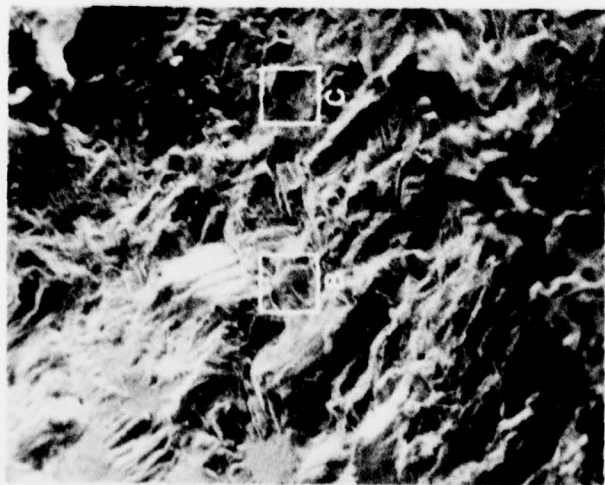
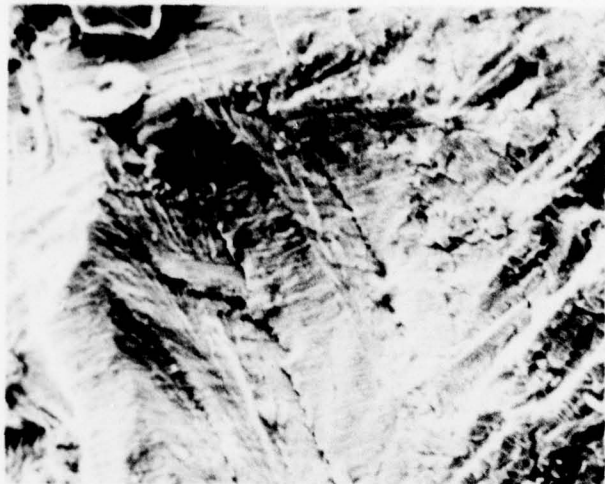
a. Fracture Surface with Cleavage
Penetration to 0.050 in.

b. Fatigue Area in Cleavage
Fracture Zone

c. Fatigue Area in Cleavage
Fracture Zone

Figure 30. Basic Cycle Specimen No. 5750 After 2489 Cycles, Tested at 950°F/150 ksi Takeoff Conditions
